Service Bulletin

Affected product:	LulzBot TAZ 6 , LulzBot Mini 3D printer
LulzBot TAZ 6:	Serial KT-PR0041(NA, EU, AU)-15000>23454
LulzBot Mini:	Serial KT-PR0035(NA, EU, AU)-00050>07499
Effective date:	August 21, 2017
Service issue:	A firmware update has been implemented to correct a bug in the heated print surface temperature management method for improved printed object cosmetics.

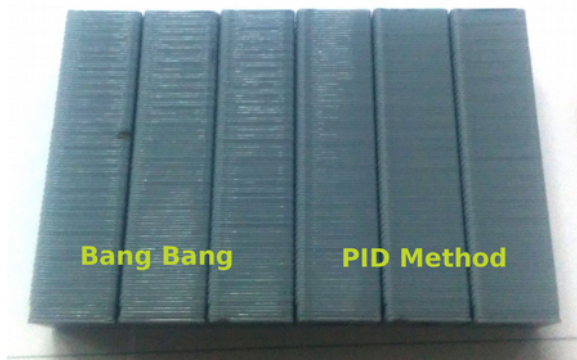
Indication: Recently the LulzBot 3D Printer user community reported that some LulzBot TAZ 6 and LulzBot Mini 3D Printers display print artifacts that appear as inconsistent layer stacking along print walls and sides, sometimes referred to as Z-axis banding. Community comments on the report noted that the firmware factory-installed on the LulzBot TAZ 6 3D Printer used the “Bang Bang” heating method for the heated print surface, as opposed to the more consistent “PID” control method.

The Aleph Objects Research and Development team confirmed that in the LulzBot TAZ 6 and early LulzBot Mini 3D Printer firmware, PID heat bed control had been erroneously disabled.

The preferred PID temperature control method can be easily restored by applying a firmware update.

Apply the updated firmware to LulzBot TAZ 6 or LulzBot Mini 3D Printers within the serial range.

1. Install Cura LulzBot Edition version **21.08** by following the instructions available at LulzBot.com/Cura.
2. Follow the instructions available at LulzBot.com/Firmware to install the default firmware for your LulzBot 3D Printer.
3. Restore your Extruder steps per unit (Esteps) by following the instructions available at LulzBot.com/Firmware.
