Service Bulletin

Affected product: LulzBot TAZ 5 Serials KT-PR0036NA-11500 and higher
LulzBot Mini Serials KT-PR0035NA-1100 and higher
Single & Dual Extruder Tool Heads v2

Service issue: Some extruder idlers may crack and eventually fail.

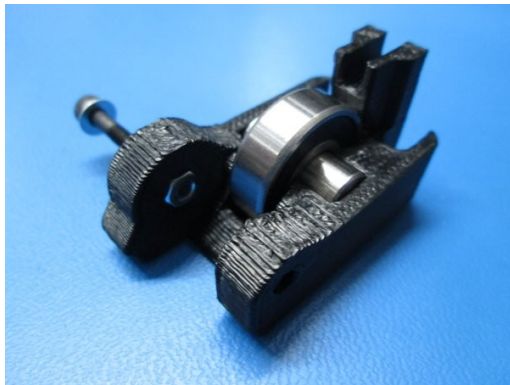
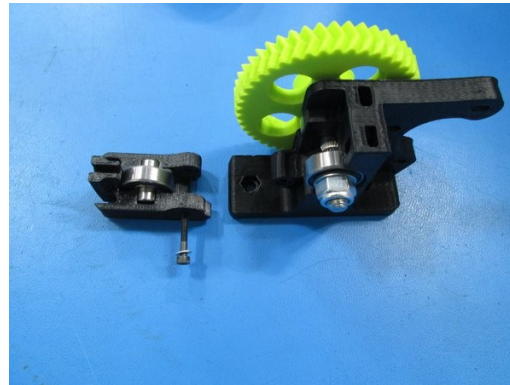
During the assembly process a sealed 608 bearing loaded onto an 8mm shaft is pressed into the 3D printed extruder idler. Some extruder idlers may be stressed during this process and may develop fine cracks that eventually lead to failure of the idler.

If your hinged idler is intact:

3D print a backup extruder idler now utilizing ABS plastic. Load the following GCODE file into Cura, or use your Graphical LCD controller to print it from the SD Card. To save the following files, click or copy the file links into a browser window.

If your extruder idler is cracked:

Contact the Support Team by sending an email to Support@LulzBot.com with the following information:

A replacement extruder idler will be sent at no cost to you. We apologize for any inconvenience this may have caused and appreciate your business.
